# ALITA

## PROPERTY INSPECTION REPORT

| PROPERTY TYPE | Villa with pool |
| REFERENCE | INS-2026-359 |

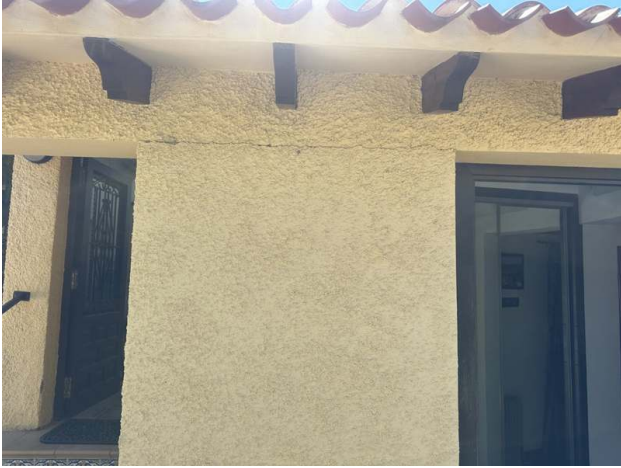
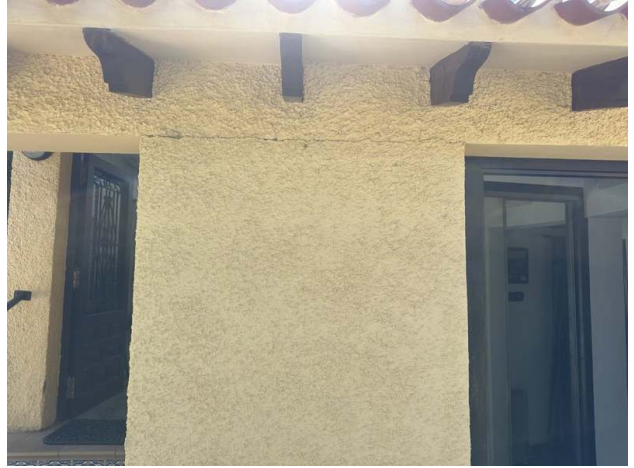
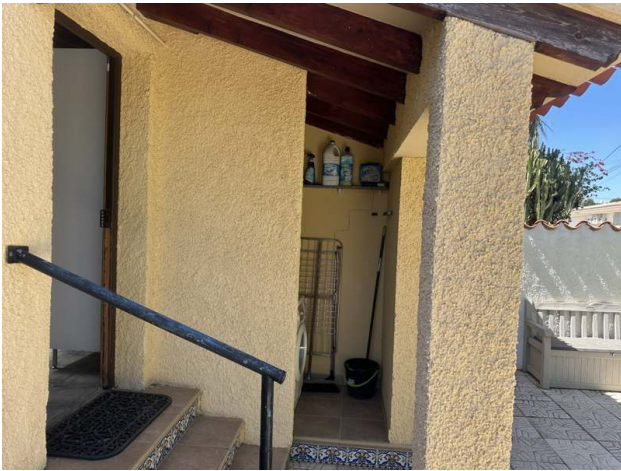
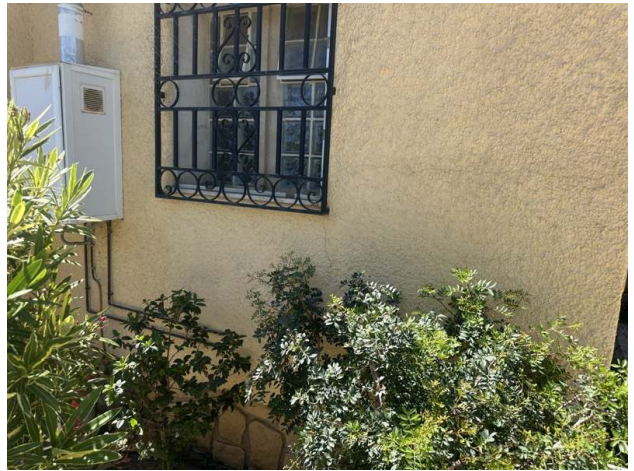
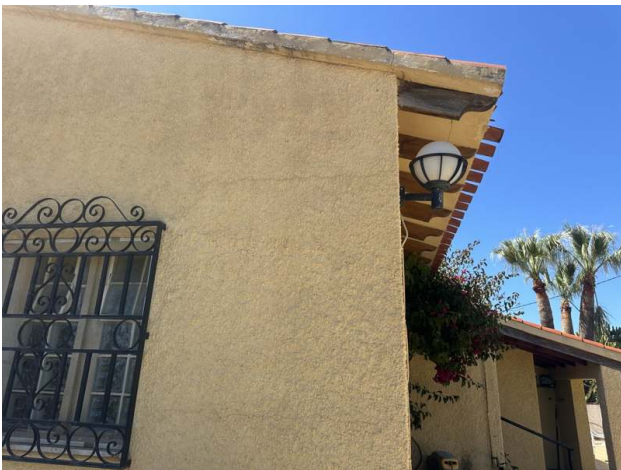
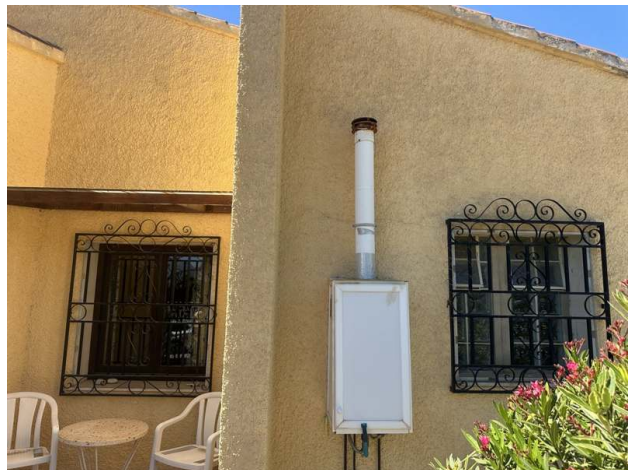
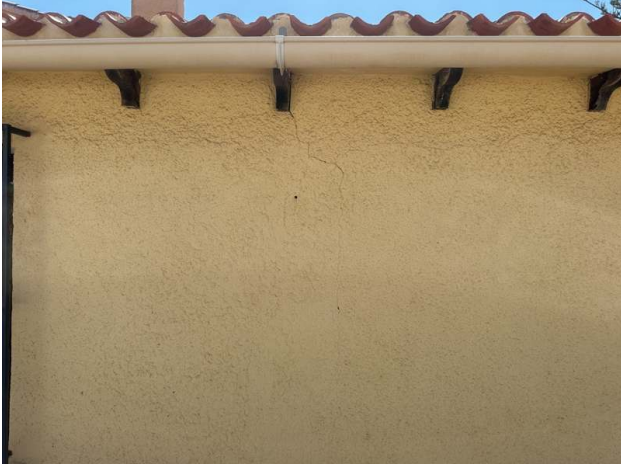
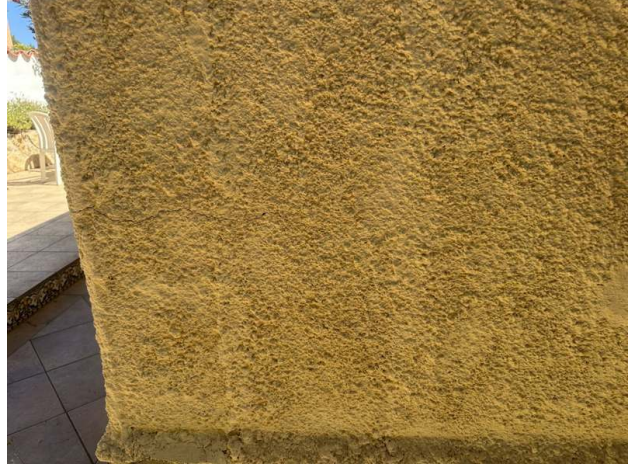
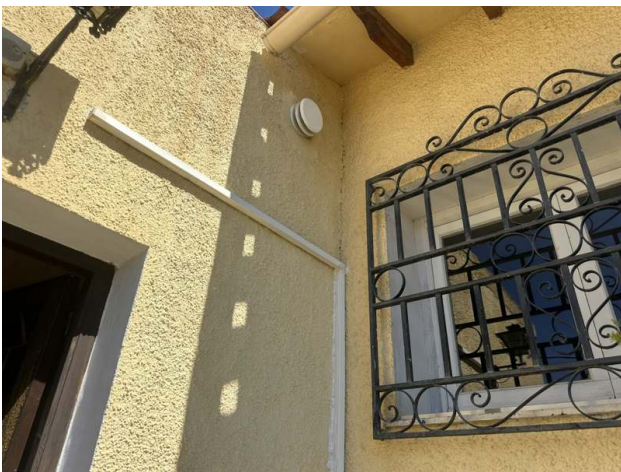
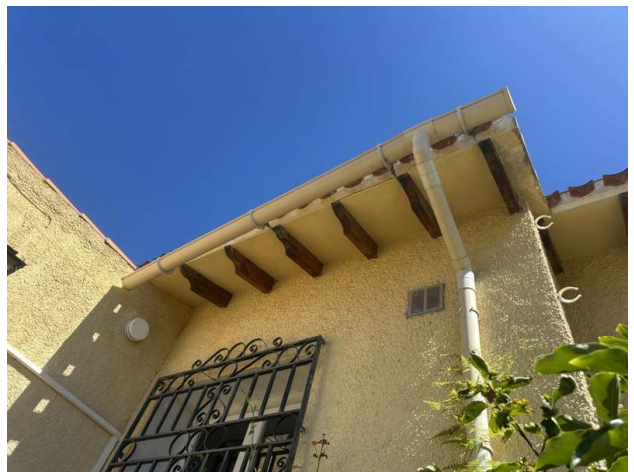
Render cracks across the outside of the house. Cosmetic only, confined to the render layer, but they'll let moisture in over time if left. Re-rendering of the affected areas recommended. See photos below.

Render cracks on the exterior façade.

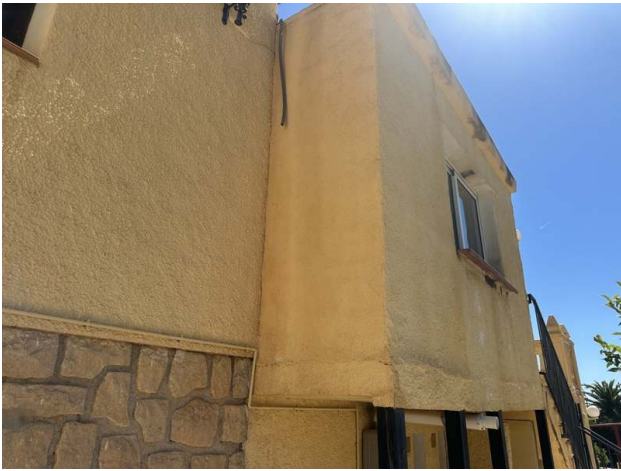
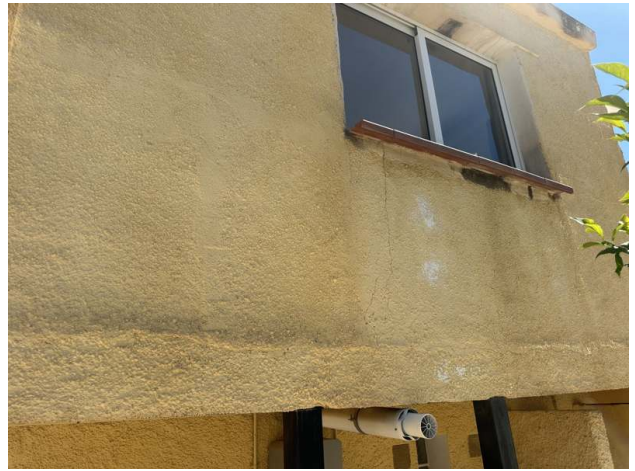
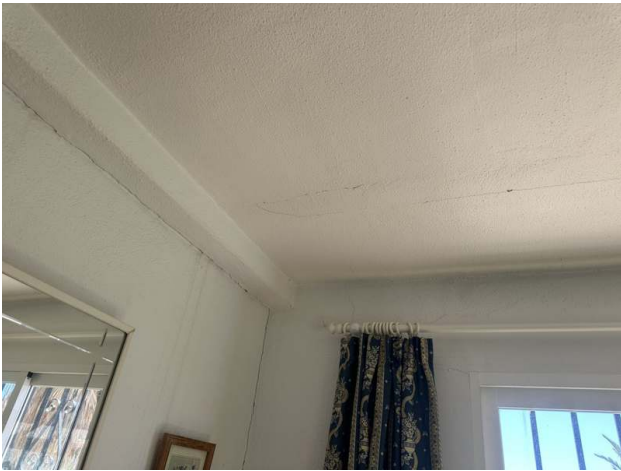
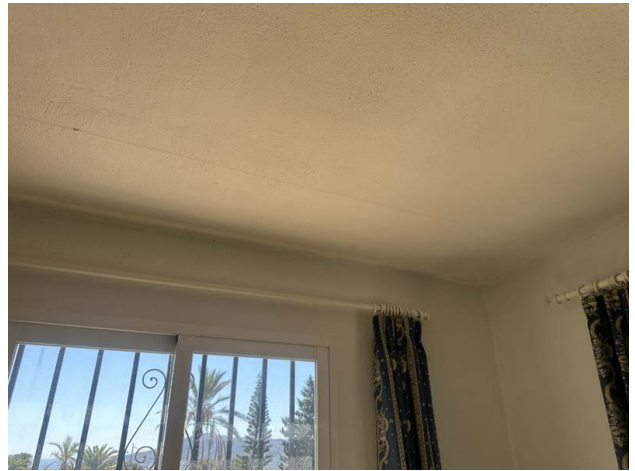
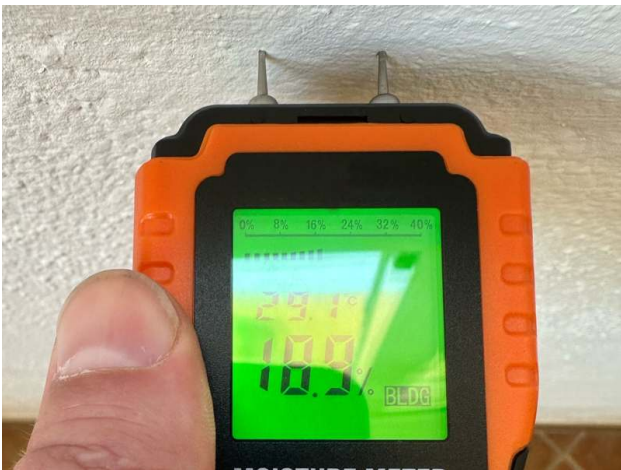
The extension structure is stable, but there's no waterproofing at all. Moisture meter reading at the wall beneath the window: 18.9%. Visible water marks and staining where the extension meets the main building, and corrosion on the steel reinforcement beams inside.

The window looks poorly installed: the render and finish around the frame are rough, and the seal between frame and wall is likely letting water in.

Master bedroom extension: corrosion and water ingress.

Remediation scope: clean and treat the steel beams (anti-corrosion), apply waterproofing membrane, re-render, re-skim, repaint. The window may need to come out and be reinstalled properly.

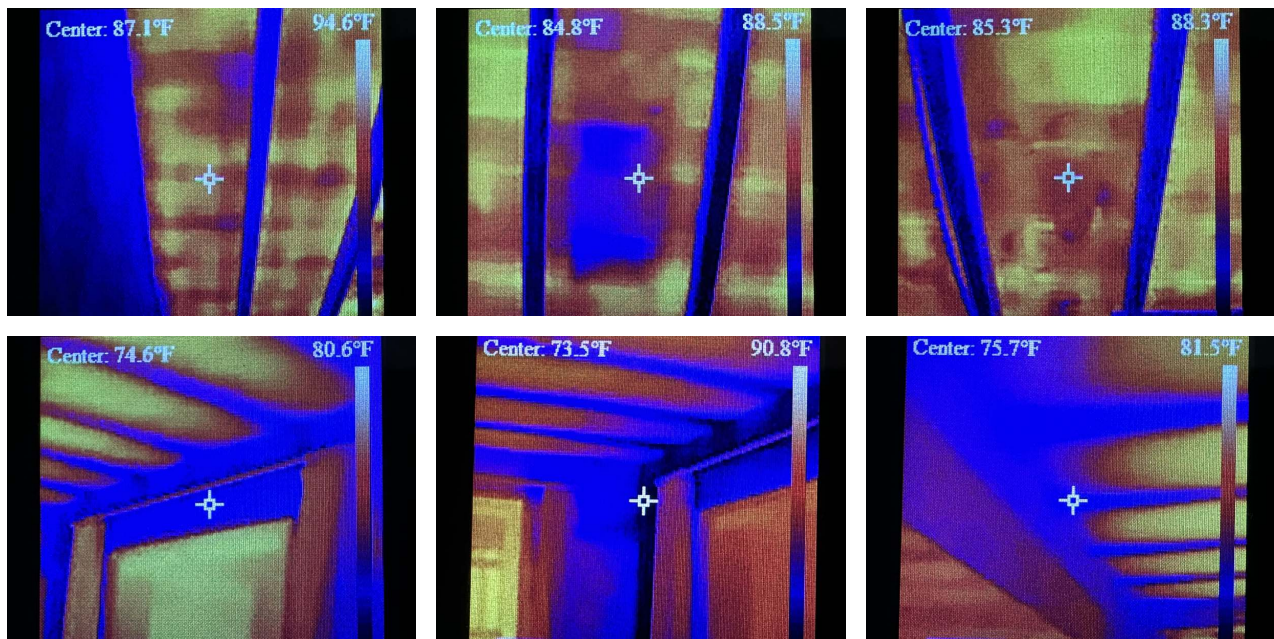
Thermal camera showed hot spots on the main room ceiling: moisture sitting beneath the surface. The extension bedroom also showed elevated humidity throughout (see roof section).

Extension bedroom registered as an abnormal thermal zone. Matches the moisture and waterproofing issues found on-site.

Thermal imaging: main room ceiling (top row), master bedroom extension (bottom row).

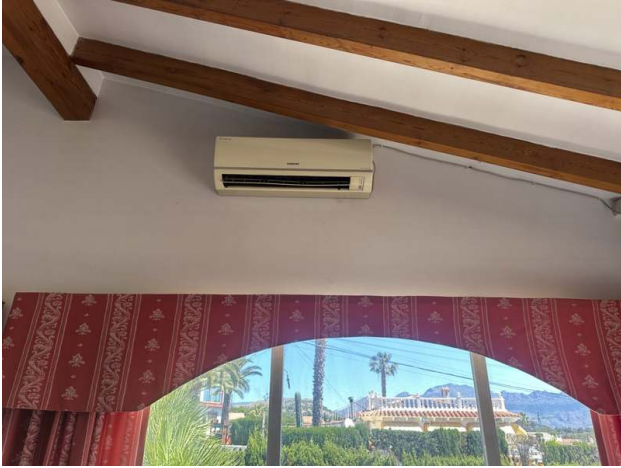
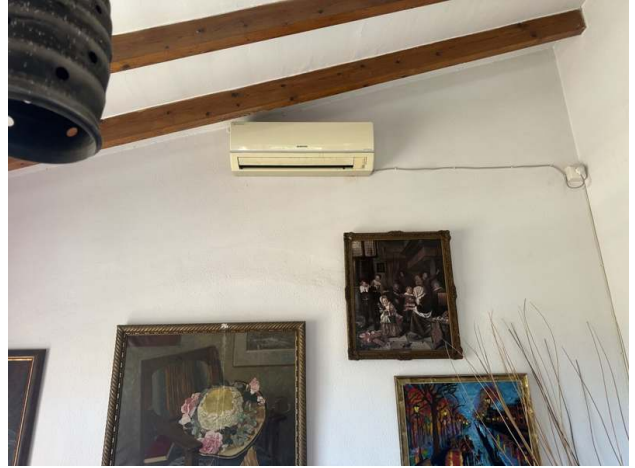
Two split units on the main terrace, both aged, need replacing. No A/C in the bedrooms or other rooms.

A/C units on the main terrace, both aged.

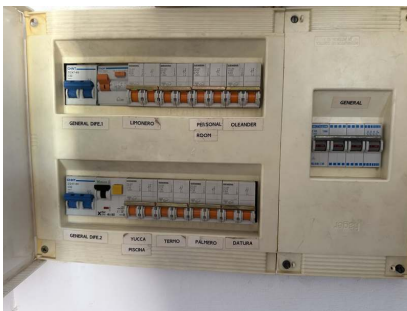
Main consumer unit (fuse box).

The consumer unit will need upgrading. Current ICP and RCD/differential are undersized for additional loads. If A/C is installed in the bedrooms, separate RCDs and dedicated breakers will be needed for each unit, and the panel will need rewiring. In its current state the board won't cope with A/C in every room.

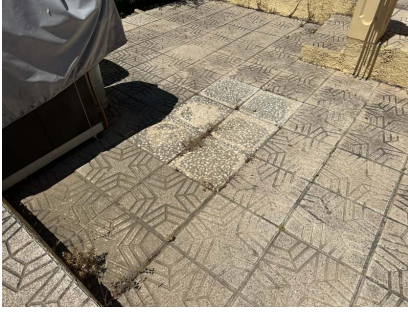
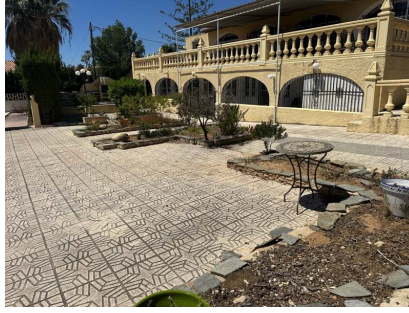
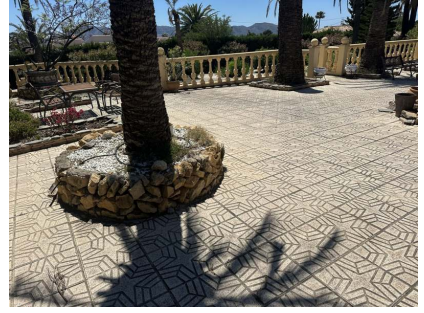
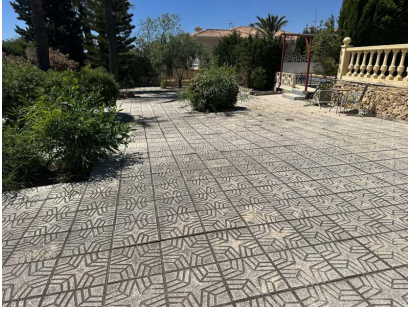
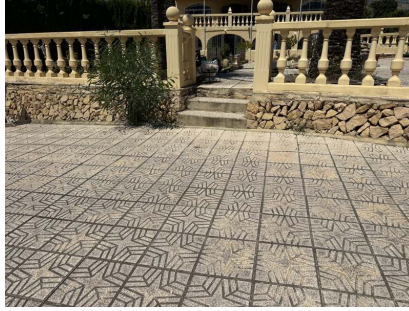
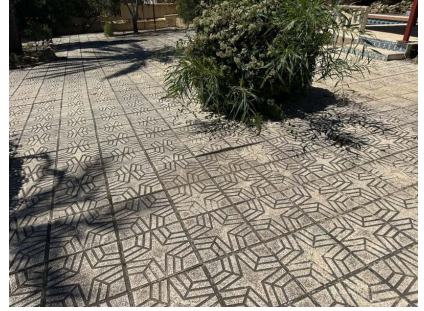
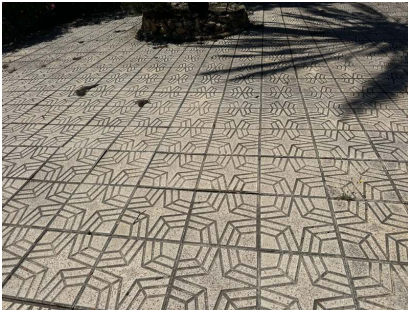
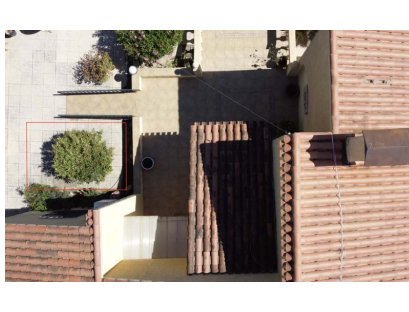
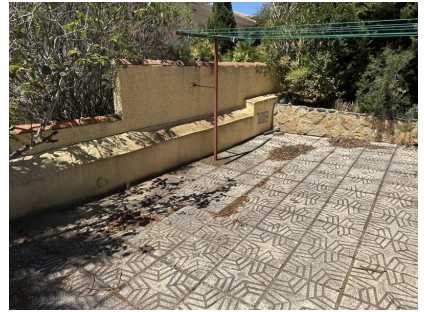
Tree roots have got under the tiles and screed across most of the terrace. Tiles lifted and damaged throughout. Repair means dealing with the roots first, then pulling up the old screed, laying new, and re-tiling the lot.

*Terrace: damaged and lifted tiles across the property.*

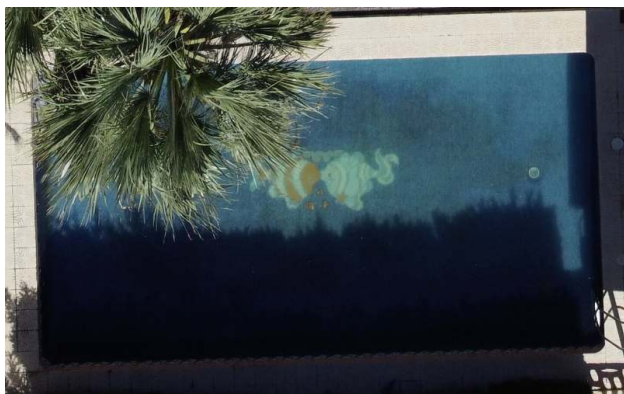
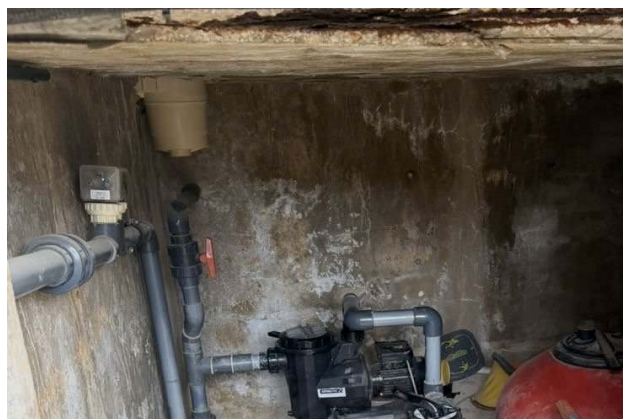
Pool is in poor condition. Tiles are debonding and missing around the full perimeter: the underlying concrete is wet, and the tile bond has failed across the whole surface. Both skimmers and impulsors are disconnected from the pipework, water is not circulating. Pool is dirty and unmaintained. Bushes overhanging the pool drop debris into the water.

Rust marks on the steel beams in the adjacent pump room point to moisture getting out through the shell. Two options: full demolition and rebuild, or pour a new concrete shell inside the existing one. We'd lean towards the second.

*Pool (drone view) and pump room: rust on beams, damp walls.*

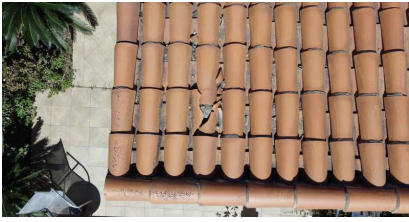
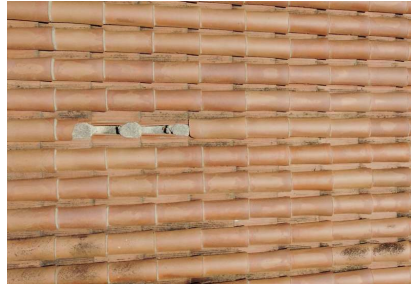
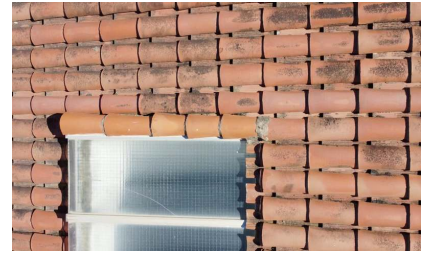
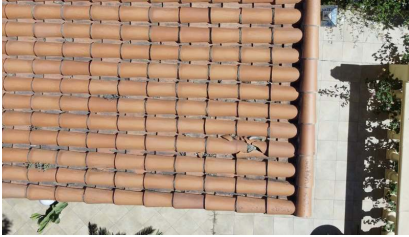
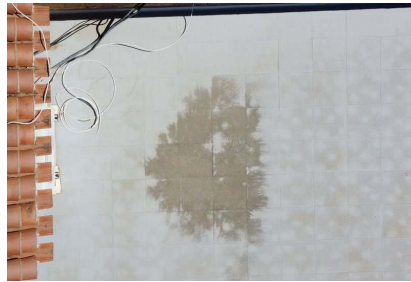
Several tiles missing on the main building, letting rainwater in. This is what's causing the moisture damage on the main room ceiling. Tile replacement required.

Extension roof: dark stain visible from above in the centre, meaning the surface is sagging and water pools there instead of draining. Contributing extra moisture to the extension. This roof will most likely need rebuilding, not just patching.

Roof: missing and broken tiles, extension roof stain (drone photography).
